Investigation of Fiber-Reinforced Polymer for Seismic Rehabilitation of Concrete Structural Frames With Unreinforced Masonry Infill

Ghassan K. Al-Chaar, Justin B. Berman,
and Steven C. Sweeney

May 2003

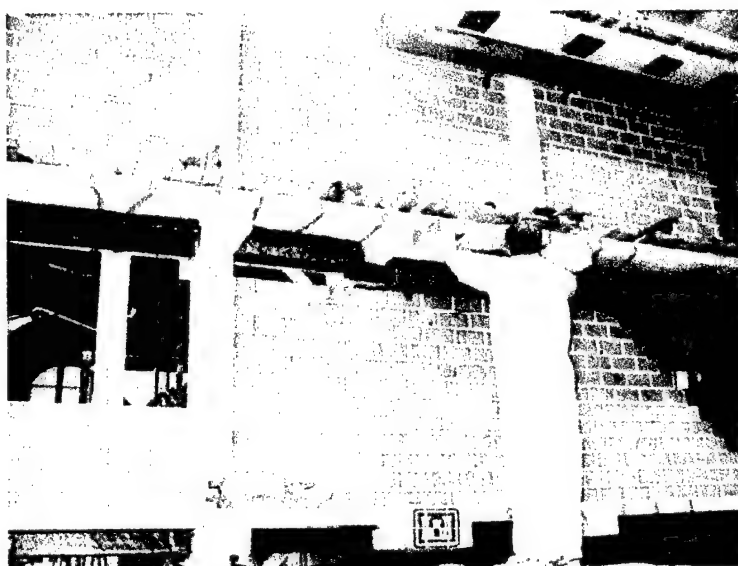
Figure 6.4. Photograph of stories two and three of the rehabilitated frame.

Figure 6.4 shows a photograph of a portion of the rehabilitated frame. The CFRP appears black and spans the lower portion of the beams, and the gray bands on the beams are the J-51 epoxy sealant. The J-56 injection epoxy is clear and not visible in the photograph.
